Professional "do-it-yourself" coating

repairs in concrete production
facilities

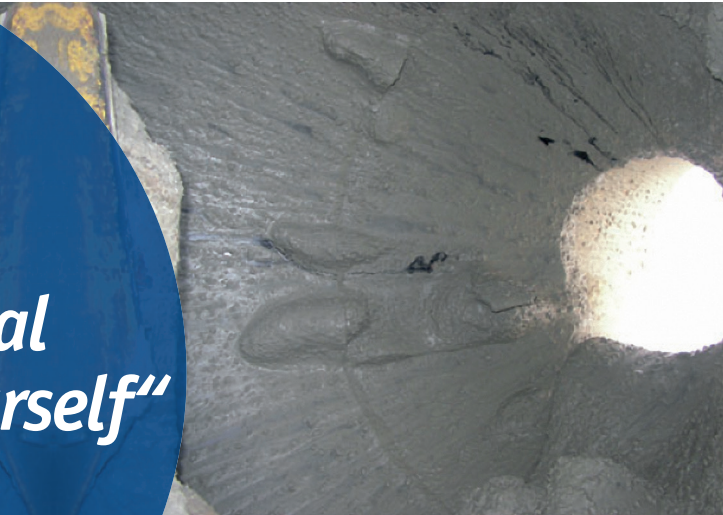
Fig. 1: Macerated rubber lining as result of release oil agent

In figure 1, the effects of release oil separating agents are visible. The rubber lining has become macerated in a seam or joint area, detached from the subsurface and undermined by concrete.

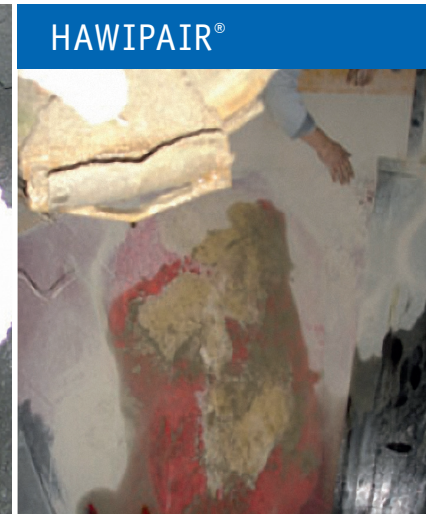
Fig. 2: Repair of a partially worn-out polyurethane coating (red) with Hawipair (white) in a discharge funnel at a ready-mix concrete production facility

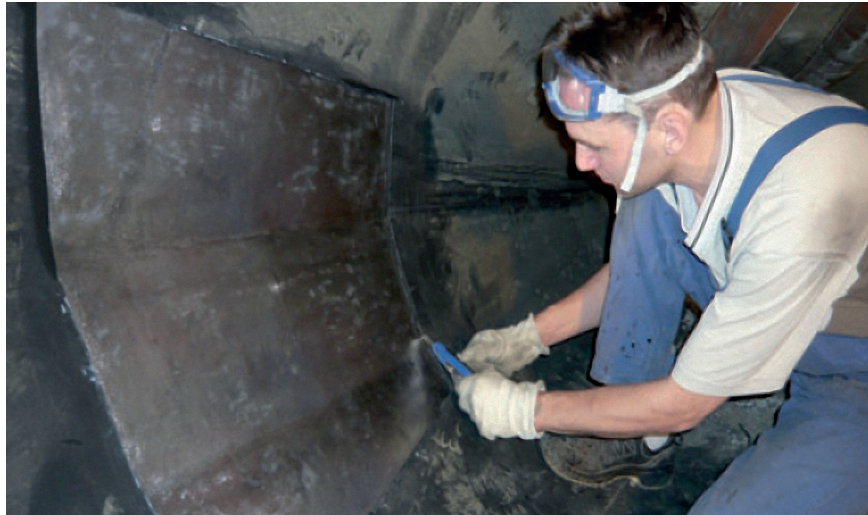
Fig. 3: Preparatory work for repairing the damaged areas

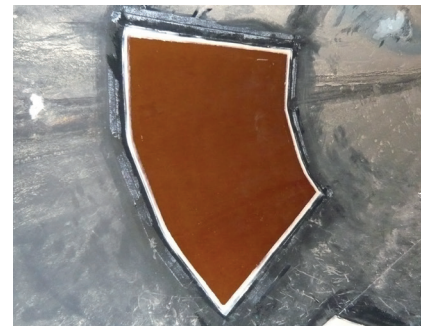
Fig. 4: Only one operation needed to fill a worn section with Hawipair® (white)

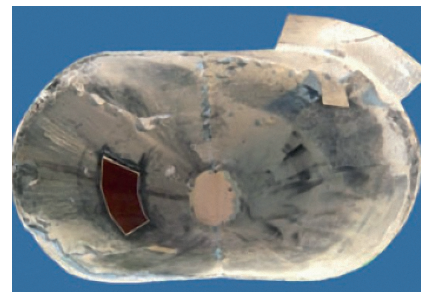
Fig. 5: Clearly visible: only the actual impact area (area of wear) has been repaired
